REPORT NUMBER 11-15-C0165A Revision 1

“Pressure Washing Resistance Test (Adhesion Effectiveness) on HUB ALERT™ Heat Sensing Labels”

Pressure Washing Resistance Test (Adhesion Effectiveness) on HUB ALERT™ Heat Sensing Labels

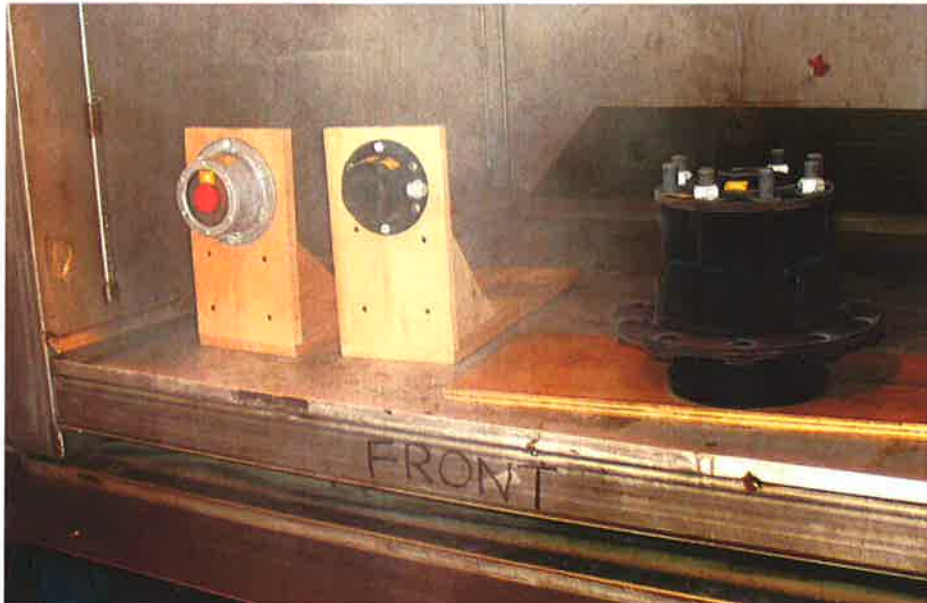
Figure 1A : Cold temperature conditioning at -32°C (-25°F).of the aluminum, plastic and steel hub caps /hub

The high and low temperature conditioning was performed in a *THERMOTRON F-94CHMV* environmental chamber in which the three hub caps were conditioned after heat sensing label application. The internal chamber conditions (temperature and RH) were monitored at 5-minute intervals by means of the *THERMOTRON 7800* control system's data logger. The test set-up is shown in Appendix A, Figure 1A.

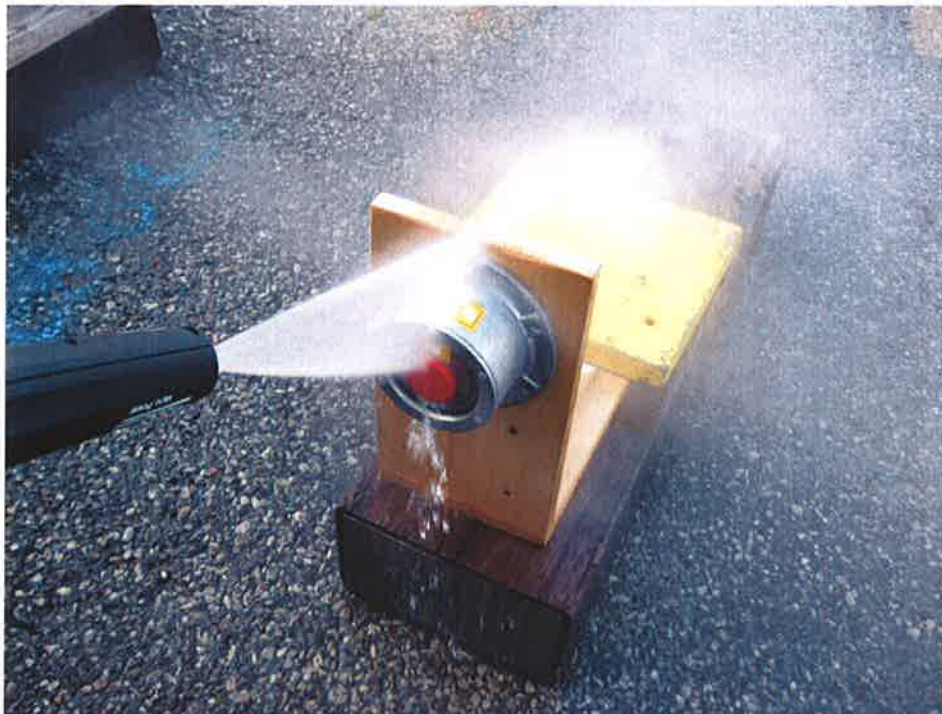
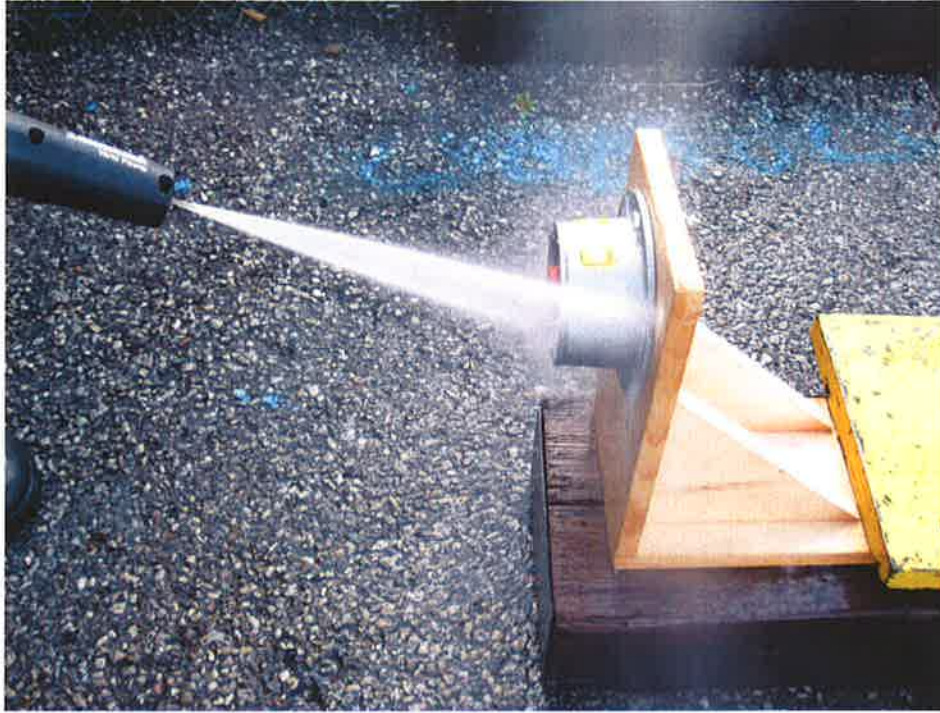
Figure 2A : Pressure-washer resistance test set-up

Figure 3A : Pressure-washer resistance test set-up

- 2000 psi pressure at a distance of 12 in. from the hub cap (from tip of spray nozzle).
- Cold tap water spray.
- Horizontal "pass-by" stroke spray.
- Labels subjected to constant water pressure for 3 seconds per stroke.
- Repeated for two additional "pass-by" strokes (total of 3 strokes).

The test-set up is shown in Appendix A, Figure 2A and Figure 3A.

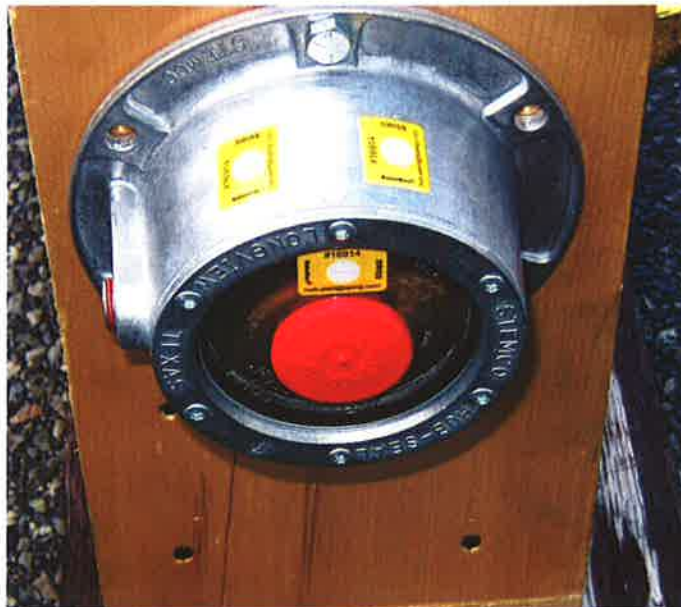
Figure 4A : Aluminum hub cap with labels – Ambient temperature, before pressure spraying

Regarding the pressure washing resistance tests performed after conditioning at ambient temperature (27°C, 81°F), none of the labels applied to the aluminum, plastic and steel hubs exhibited any visible loss of adhesion after the pressure spraying, nor any other visible signs of deterioration. This was documented with photographs taken before and after the pressure washing resistance tests, as follows (see Appendix A):

- Figure 4A - Hub Alert™ heat sensing labels applied to aluminum hub (before pressure washing);
- Figure 5A - Hub Alert™ heat sensing labels applied to plastic hub (before pressure washing);
- Figure 6A - Hub Alert™ heat sensing labels applied to steel hub (before pressure washing);
- Figure 7A - Hub Alert™ heat sensing labels applied to aluminum hub (after pressure washing);
- Figure 8A - Hub Alert™ heat sensing labels applied to plastic hub (after pressure washing);
- Figure 9A - Hub Alert™ heat sensing labels applied to steel hub (after pressure washing).

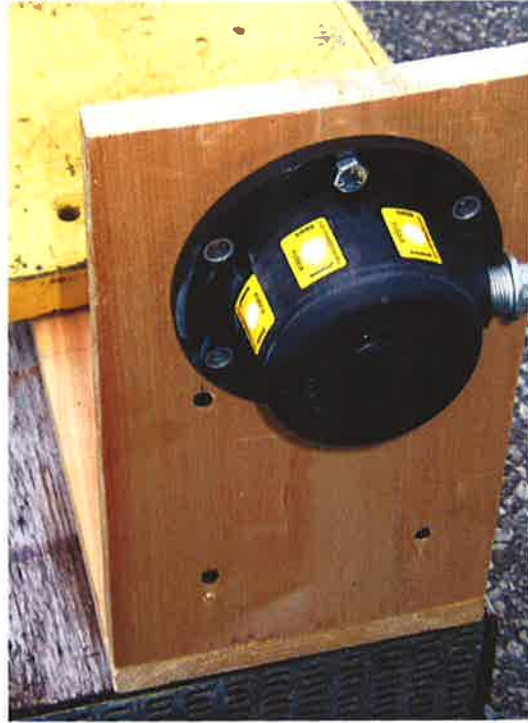
Figure 5A : Plastic hub cap with labels – Ambient temperature, before pressure spraying

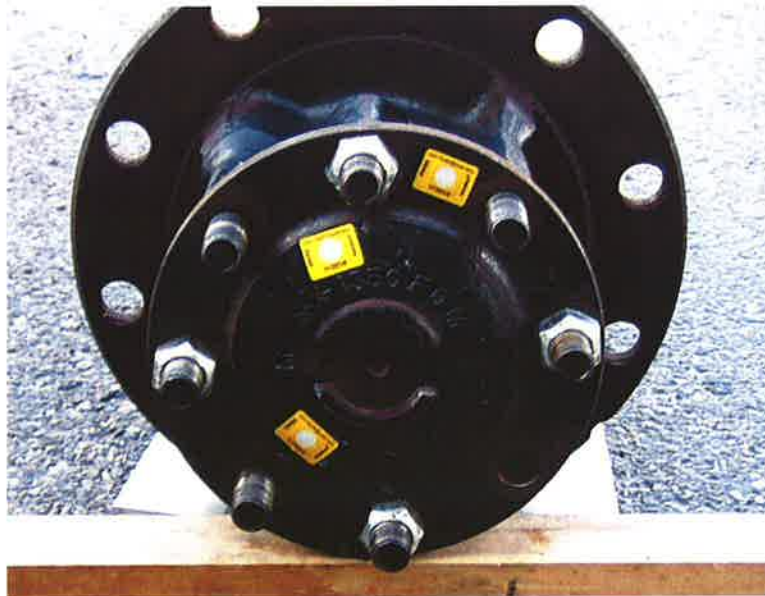
Figure 6A : Steel hub cap with labels – Ambient temperature, before pressure spraying

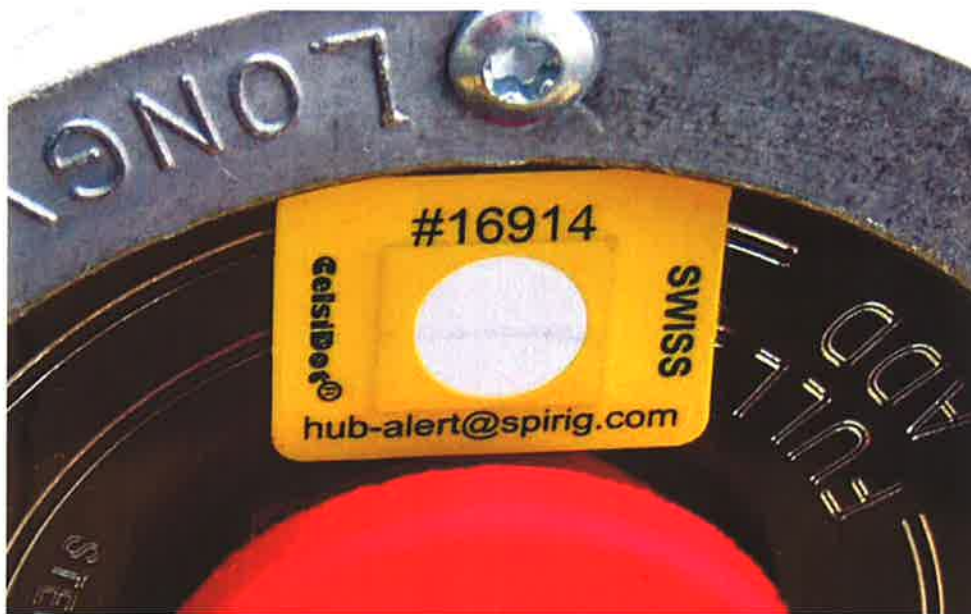
Figure 7A : Aluminum hub cap with labels – Ambient temperature, after pressure spraying

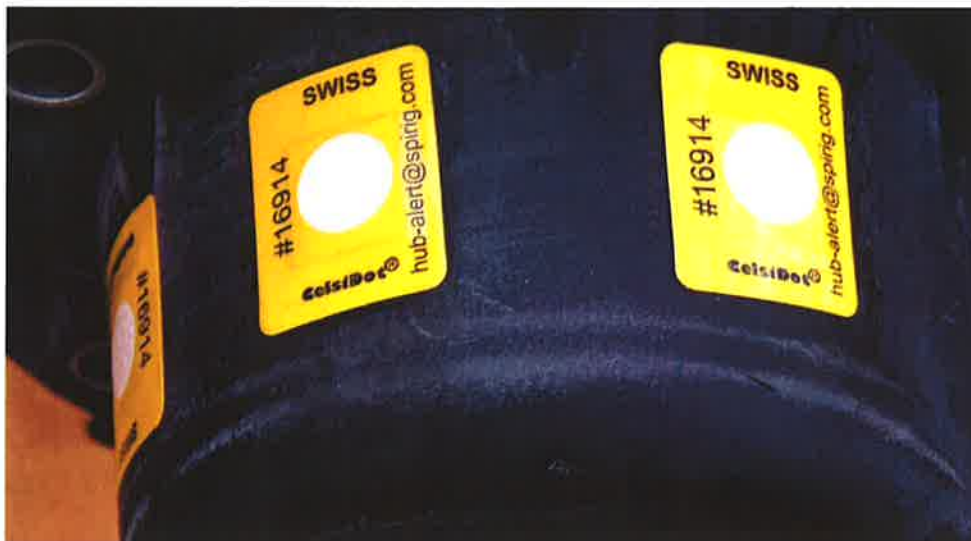
Figure 8A : Plastic hub cap with labels – Ambient temperature, after pressure spraying

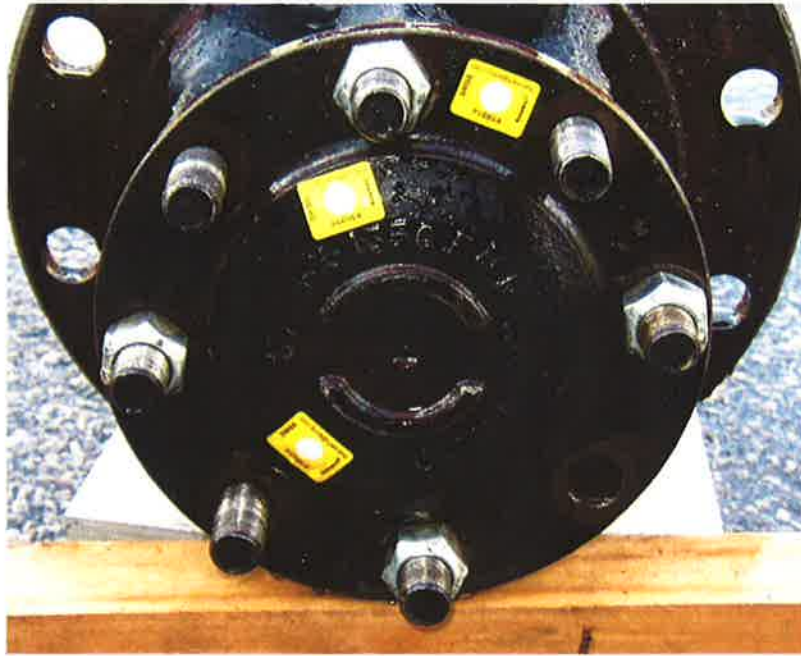
Figure 9A : Steel hub cap with labels – Ambient temperature, after pressure spraying

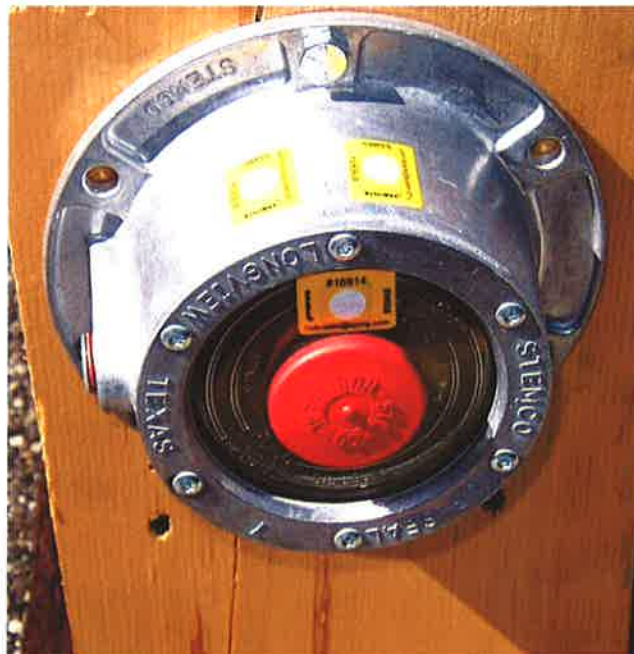
Figure 10A : Aluminum hub cap with labels – Hot temperature, before pressure spraying

Regarding the pressure washing resistance tests performed after conditioning at hot temperature (107°C, 225°F), none of the labels applied to the aluminum, plastic and steel hubs exhibited any visible loss of adhesion after the pressure spraying, nor any other visible signs of deterioration. This was documented with photographs taken before and after the pressure spray test, as follows (see Appendix A):

- Figure 10A - Hub Alert™ heat sensing labels applied to aluminum hub (before pressure washing);
- Figure 11A - Hub Alert™ heat sensing labels applied to plastic hub (before pressure washing);
- Figure 12A - Hub Alert™ heat sensing labels applied to steel hub (before pressure washing);
- Figure 13A - Hub Alert™ heat sensing labels applied to aluminum hub (after pressure washing);
- Figure 14A - Hub Alert™ heat sensing labels applied to plastic hub (after pressure washing);
- Figure 15A - Hub Alert™ heat sensing labels applied to steel hub (after pressure washing).

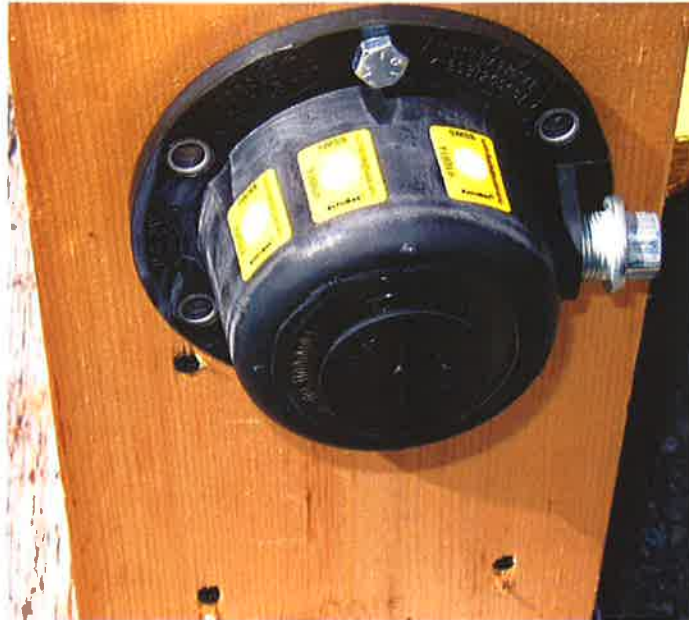
Figure 11A : Plastic hub cap with labels – Hot temperature, before pressure spraying

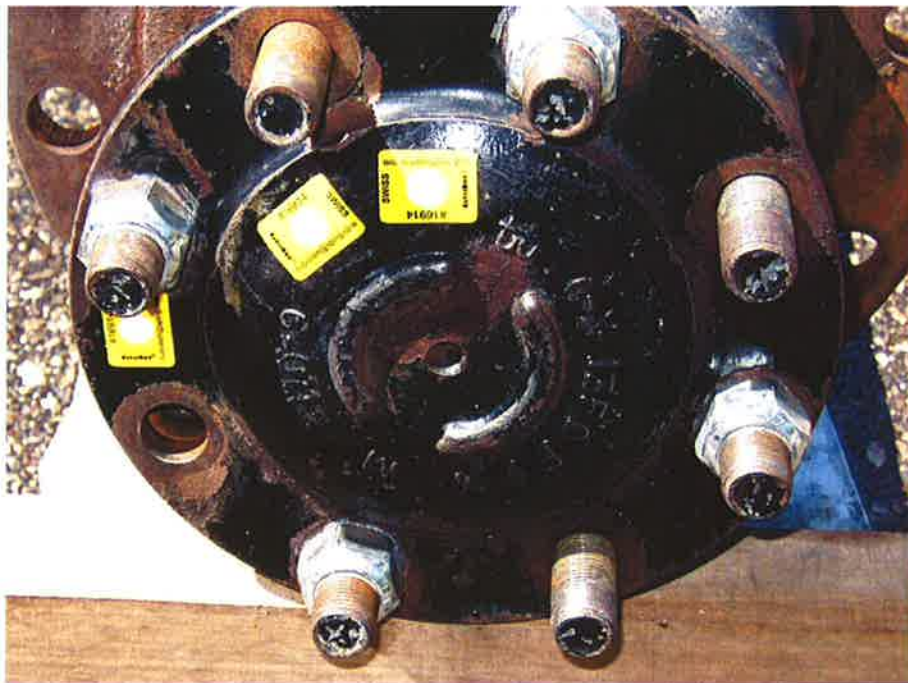
Figure 12A : Steel hub cap with labels – Hot temperature, before pressure spraying

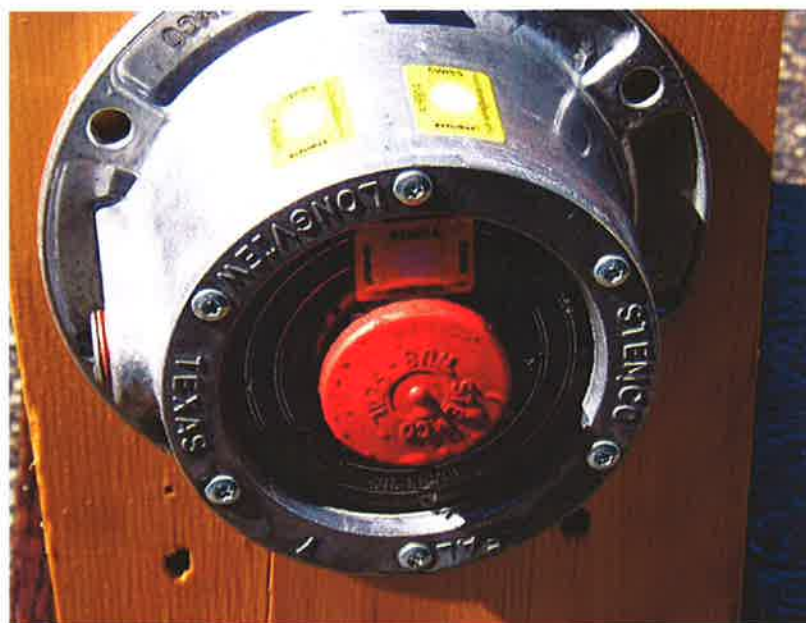
Figure 13A : Aluminum hub cap with labels – Hot temperature, after pressure spraying

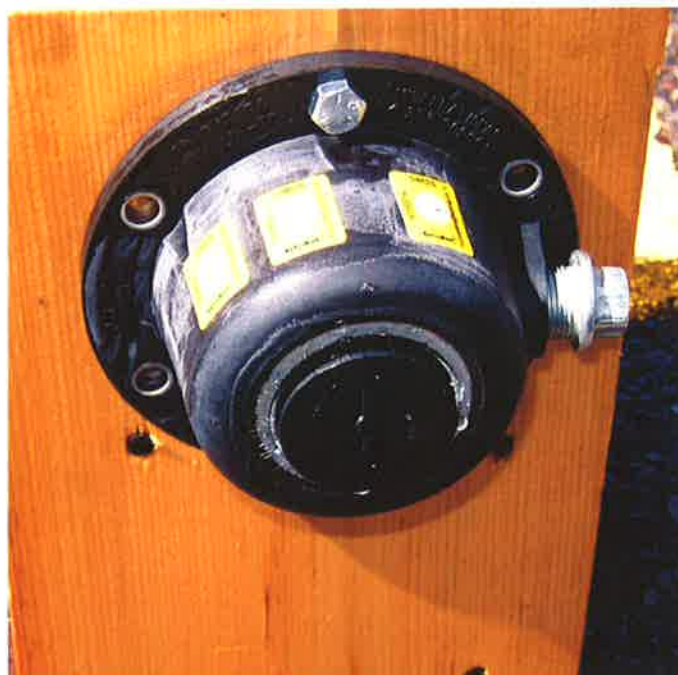
Figure 14A : Plastic hub cap with labels – Hot temperature, after pressure spraying

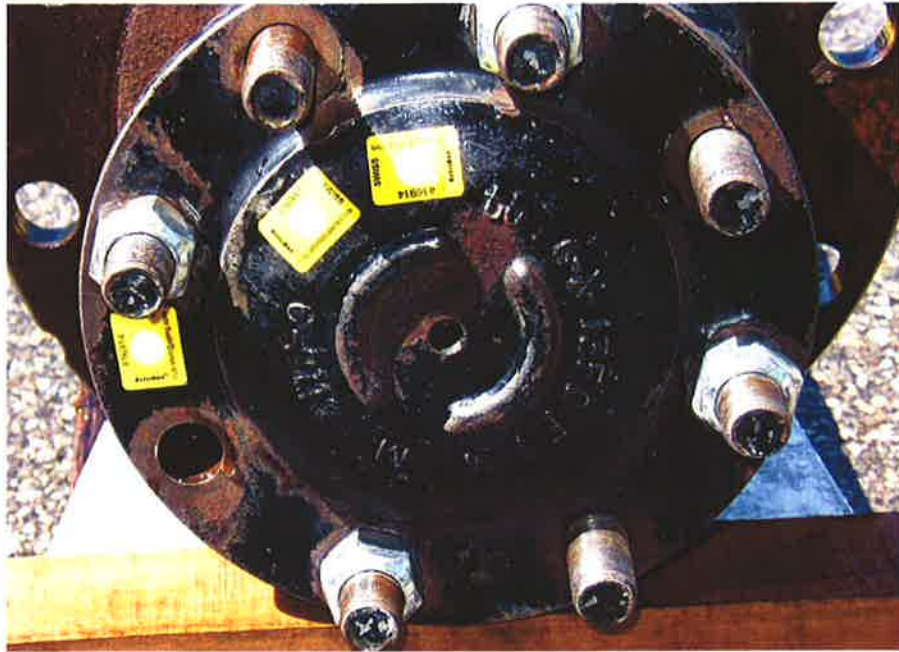
Figure 15A : Steel hub cap with labels – Hot temperature, after pressure spraying

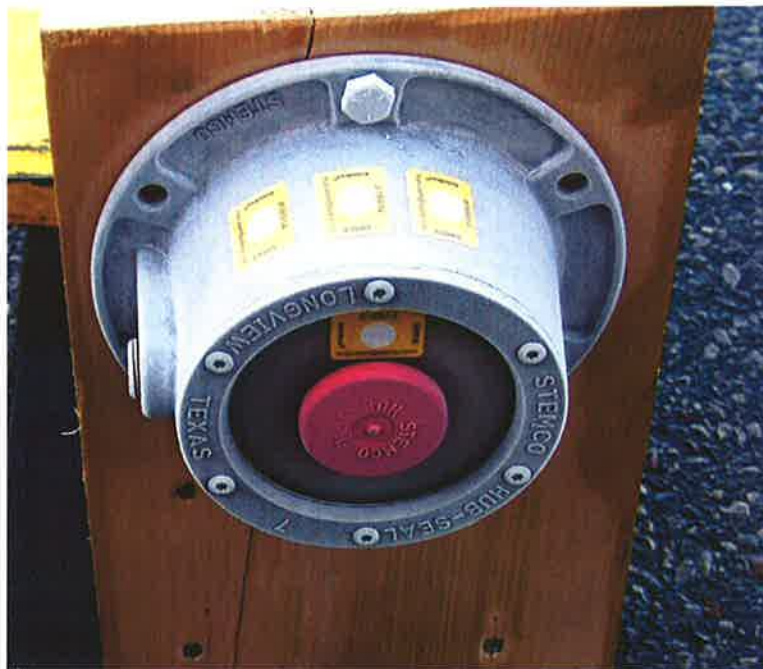
Figure 16A : Aluminum hub cap with labels – Cold temperature, before pressure spraying

Regarding the pressure washing resistance tests performed after conditioning at cold temperature (-32°C, -25°F), none of the labels applied to the aluminum, plastic, and steel hubs exhibited any visible loss of adhesion after the pressure spraying, nor any other visible signs of deterioration. This was documented with photographs taken before and after the pressure spray test, as follows (see Appendix A):

- Figure 16A - Hub Alert™ heat sensing labels applied to aluminum hub (before pressure washing);
- Figure 17A - Hub Alert™ heat sensing labels applied to plastic hub (before pressure washing);
- Figure 18A - Hub Alert™ heat sensing labels applied to steel hub (before pressure washing);
- Figure 19A - Hub Alert™ heat sensing labels applied to aluminum hub (after pressure washing);
- Figure 20A - Hub Alert™ heat sensing labels applied to plastic hub (after pressure washing);
- Figure 21A - Hub Alert™ heat sensing labels applied to steel hub (after pressure washing).

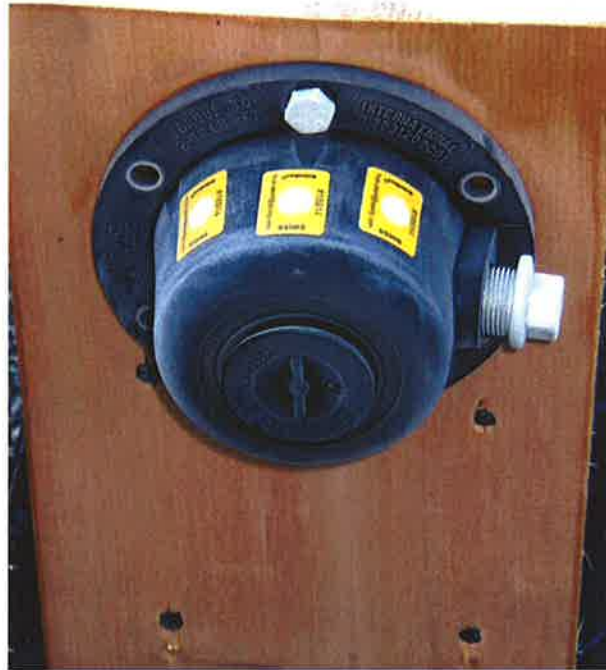
Figure 17A : Plastic hub cap with labels – Cold temperature, before pressure spraying

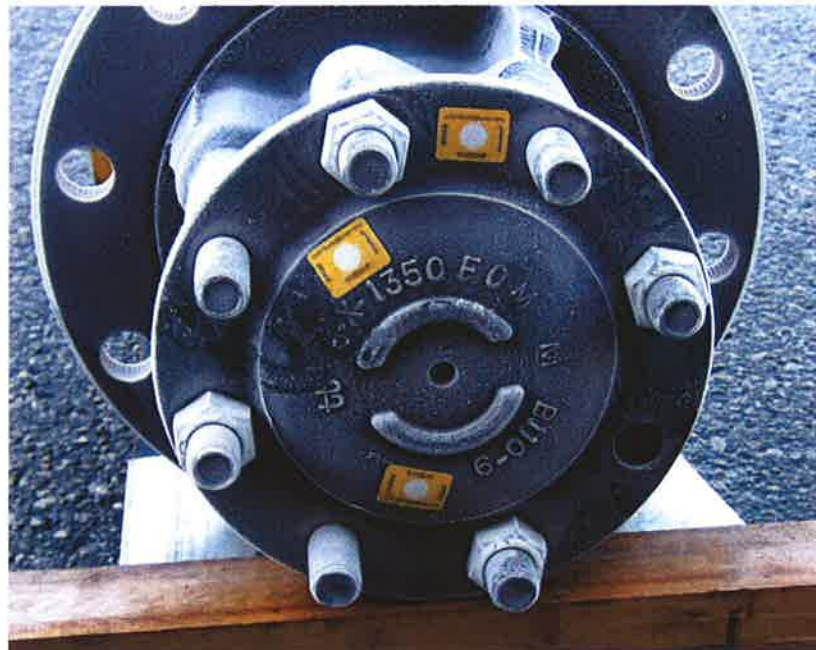
Figure 18A : Metal hub cap with labels – Cold temperature, before pressure spraying

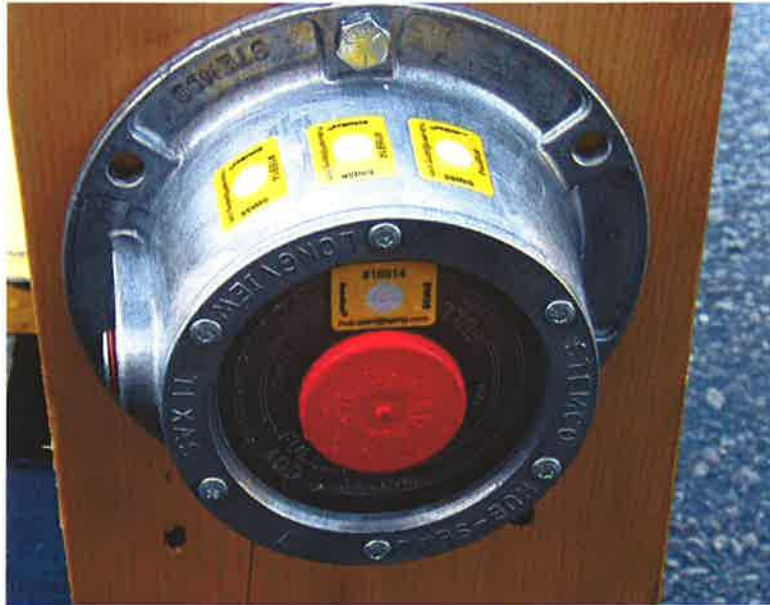
Figure 19A : Aluminum hub cap with labels – Cold temperature, after pressure spraying

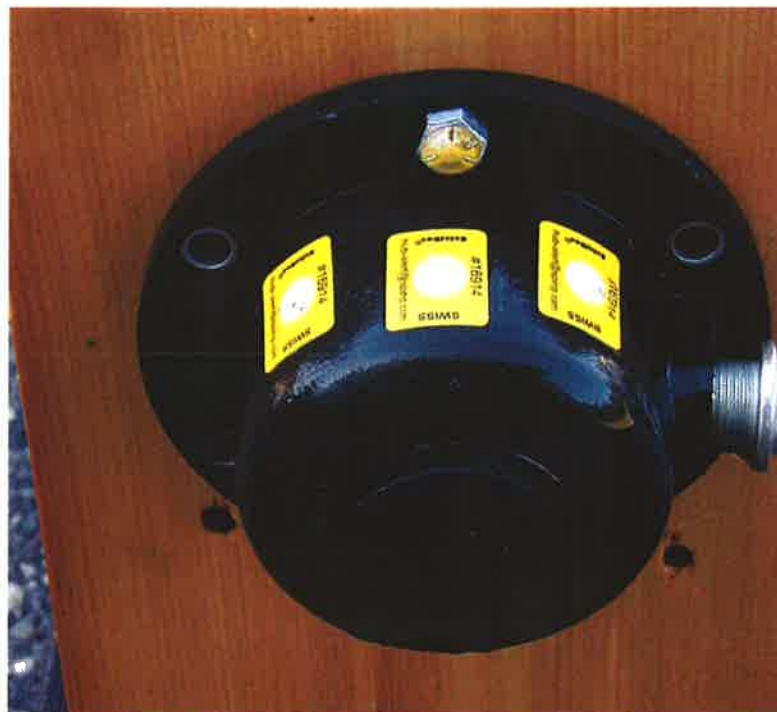
Figure 20A : Plastic hub cap with labels – Cold temperature, after pressure spraying

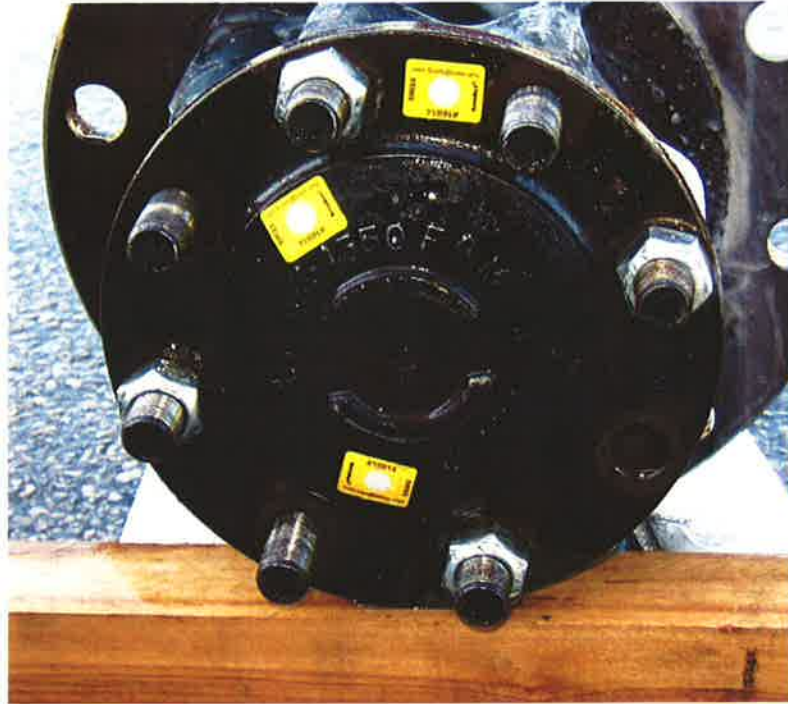
Figure 19A : Metal hub cap with labels – Cold temperature, after pressure spraying

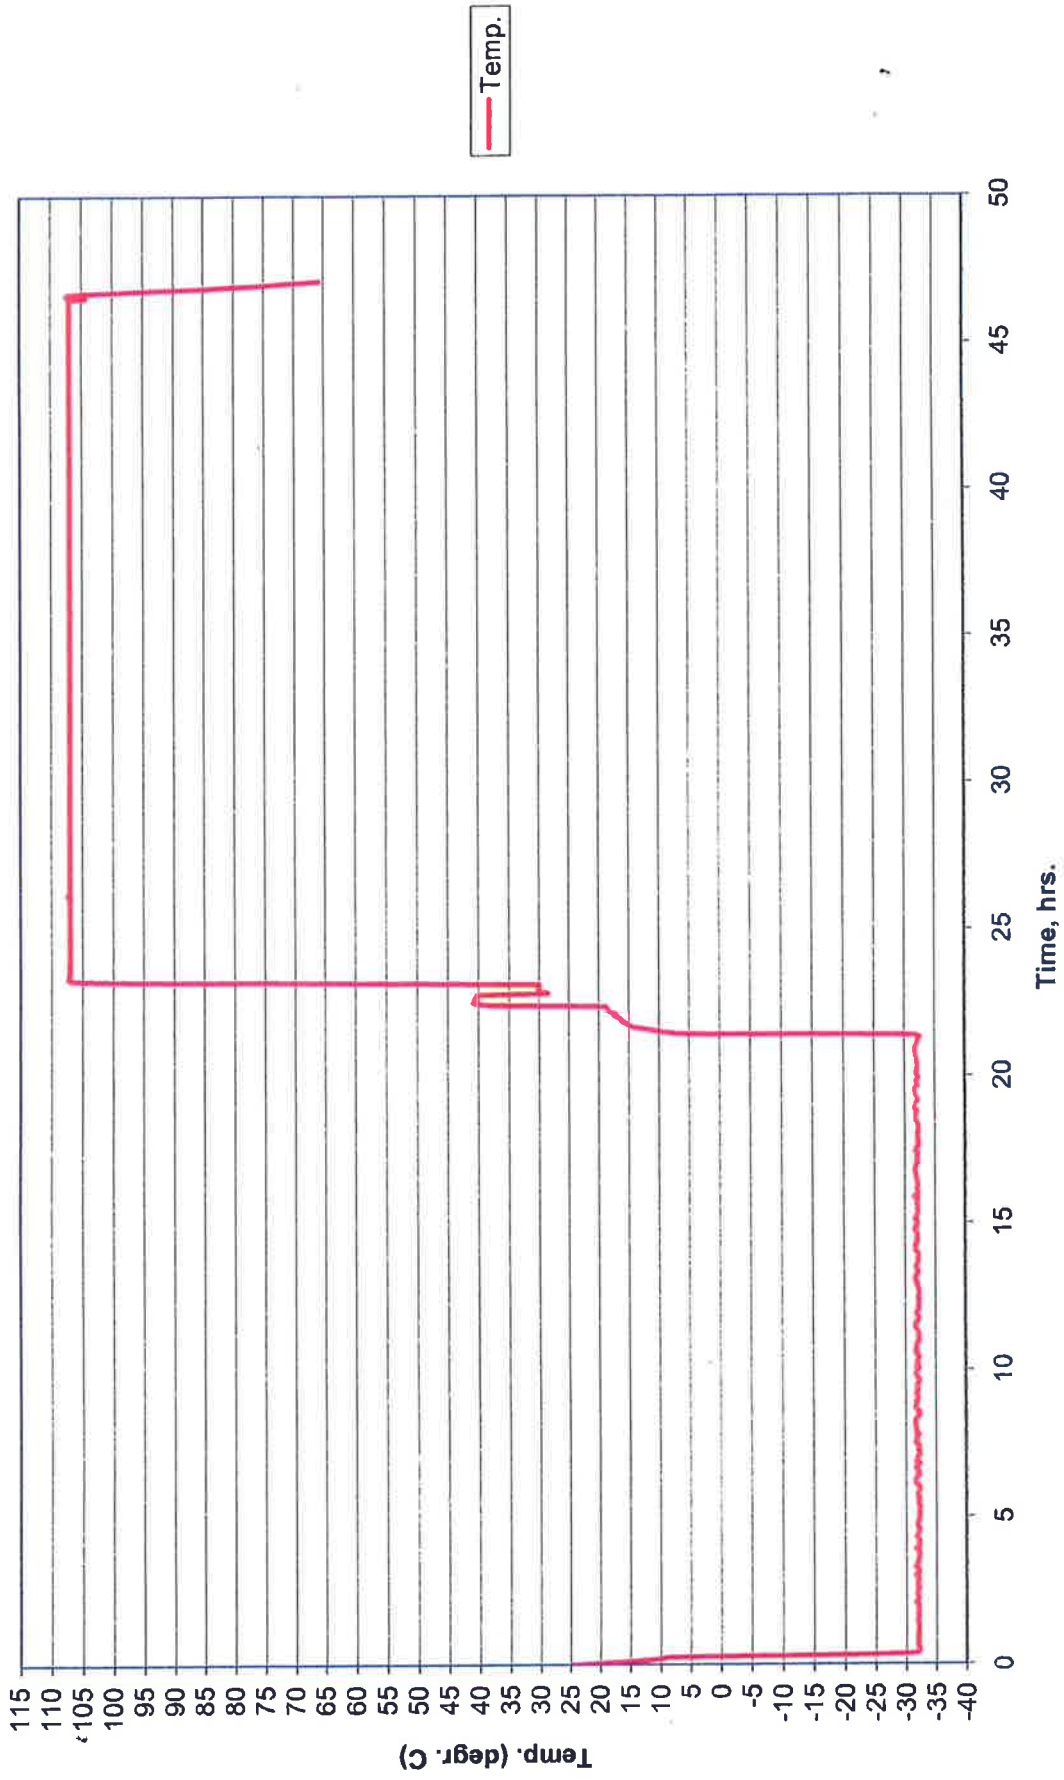
FIGURE 1B

Hub Cap Thermal Soaks (Internal Chamber Temperature)

The pressure washing resistance tests were performed on HUB ALERT™ heat sensing labels applied to aluminum, plastic and steel hub caps after conditioning at ambient temperature (27°C, 81°F), hot temperature (107°C, 225°F), and cold temperature (-32°C, -25°F). The hot and cold temperature conditioning was performed in a *THERMOTRON* chamber. A graph of the chamber conditions is provided in Appendix B, Figure 1B.
